Manhole Inspection Summary

Manhole # S07II2005MH

Insp Date: **7/6/06 12:00 AM**

Location Address: **6306 PIMILICO RD**

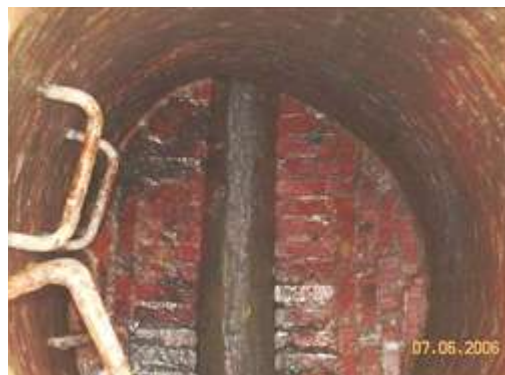
Top View

Comments **Whole MH is wet at the time of inspection even bench.**

corrosion starts on steps. unknown source of infiltration in MH.

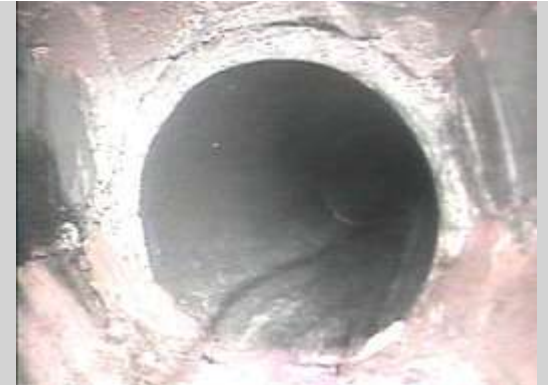
8 in. Circular Gravity Sewer Pipe Out @ 12 O'Clock

Infiltration: **None** Pipe Seal Cond: **Unknown**

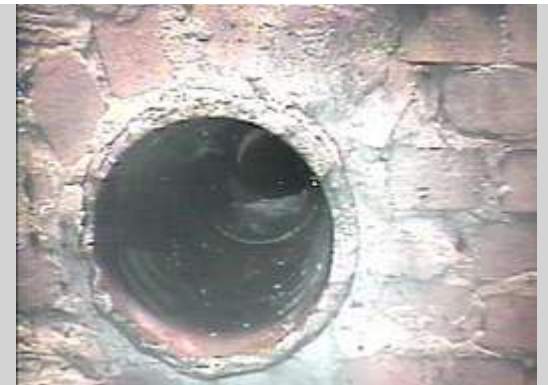
8 in. Circular Gravity Sewer Pipe In @ 6 O'Clock

Infiltration: **None** Pipe Seal Cond: **Unknown**

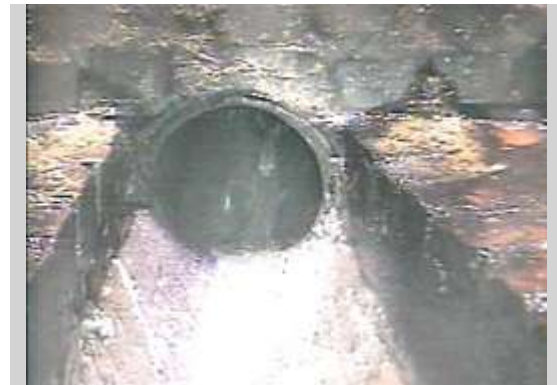
Drop In @ 6 O'Clock

Drop Condition: **Open**
